**DAM INSPECTION REPORT
FOR
HORSESHOE LAKE LEVEL
CONTROL STRUCTURE
2010 Inspection**

HILLSDALE COUNTY

July, 2010

Inspection Date: May 12, 2010

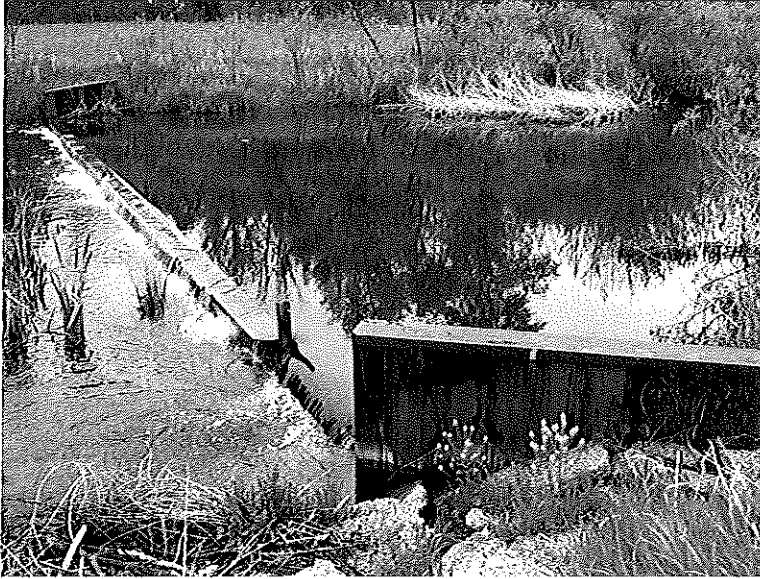
Lake Level Control Structure
from Left

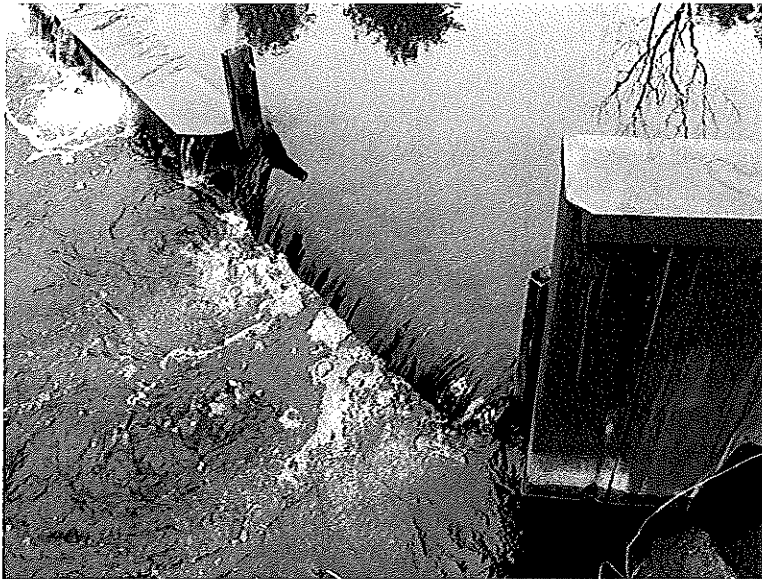
<p>STOPLOG VALVES AND GATES (open and close to check condition): Check location of top stoplog in relation to top of riser pipe intake box or fixed crest, for leakage, and condition of stoplogs, valves and gates.</p> <p>Stop logs in good condition. Some sediment infill upstream.</p>
<p>OUTLET PIPE: Check for damage from ice, logs, vandalism; inside discharge pipe for settlement and/or joint separation; condition of pipe coating.</p> <p>N/A</p>

Stop Log Bay
